COAST GUARD RESEARCH AND DEVELOPMENT CENTER GROTON CT
TRANSITORY FIRE RESISTANCE OF TANKER LIFEBOATS.(U)
FEB 80 D E BEENE
CGR/DC-27/79

1. Report No. 19 D-19-80	2. Government Accession No. AD-A084257	3. Recipient's Catalog No.	
4. Title and Subtitle U Transitory Fire Resistance of Tanker Lifeboats		5. Report Date 12 February 1980	6. Performing Organization Code

7. Author(s) 10 David E. Beene, Jr.		8. Performing Organization Report No. R&DC 27/79	
9. Performing Organization Name and Address United States Coast Guard Research and Development Center Avery Point Groton, Connecticut 06340		10. Work Unit No. (TRAIS)	11. Contract or Grant No. 72132

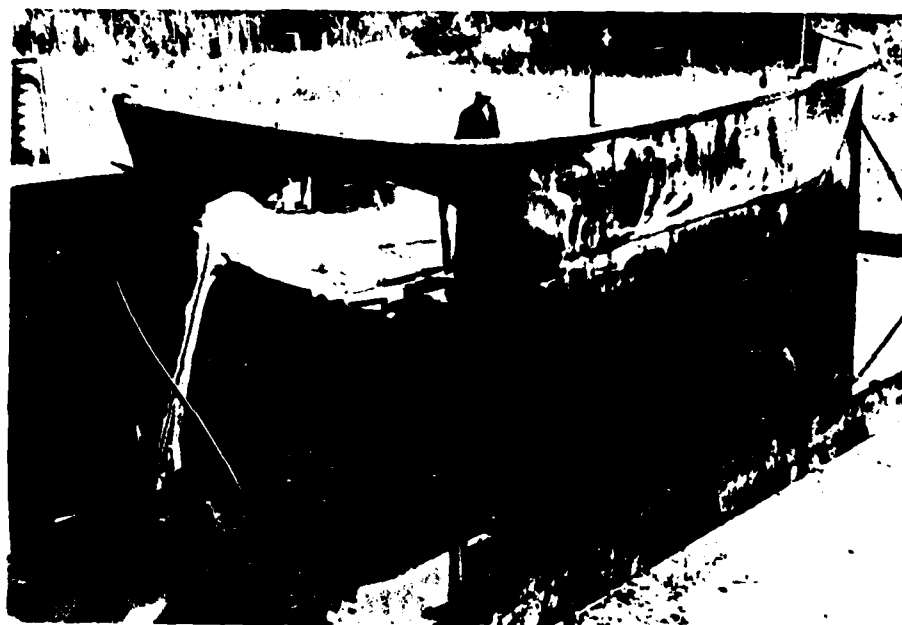
Figure 3
Aluminum Lifeboat Failure

The lifeboat was constructed of 6061 aluminum alloy in the T6 heat treated condition. Its hull was 0.09 inches (0.23 cm) thick.² Fifty seconds into the one-minute test fire an 18 square foot (1.67 sq m) section of

the hull melted and collapsed. At the conclusion of the one-minute test, twenty percent of the hull had melted (Figure 3). At the end of the two-minute test, the entire hull had melted. Only the keel, thwart brackets, and gunwale remained. They were 1.0 inch (2.54 cm), 0.25 inch (0.64 cm) and 0.38 inch (0.95 cm) thick respectively. At the time of the hull failure, the flame temperatures had reached 1560°F (849°C) (Figure 4) and the recorded heat flux was 16 BTUs per square foot per second (Figure 5). At this point, the lifeboat's wooden structures and its fiberglass buoyancy tanks were also aflame. At the conclusion of each test, only the flames in the pen were extinguished. The lifeboat interior and its buoyancy tanks were permitted to burn in order to record length of burning and to determine if they were self-extinguishing. The wooden interior burned itself out six minutes after test pen extinguishment while the foam-filled buoyancy tanks were finally extinguished after twenty-five minutes as they displayed no tendency toward self-extinguishment. The burning foam (rigid polyurethane) in the fiberglass tanks could not be extinguished by dry chemical agents and instead had to be extinguished by using the backup water spray system.
